Your Inspection Report

427 Queenston Street
St.Catharines, ON L2P2Y3

RE: Report No. 1239, v.2
427 Queenston Street
St.Catharines, ON
L2P2Y3

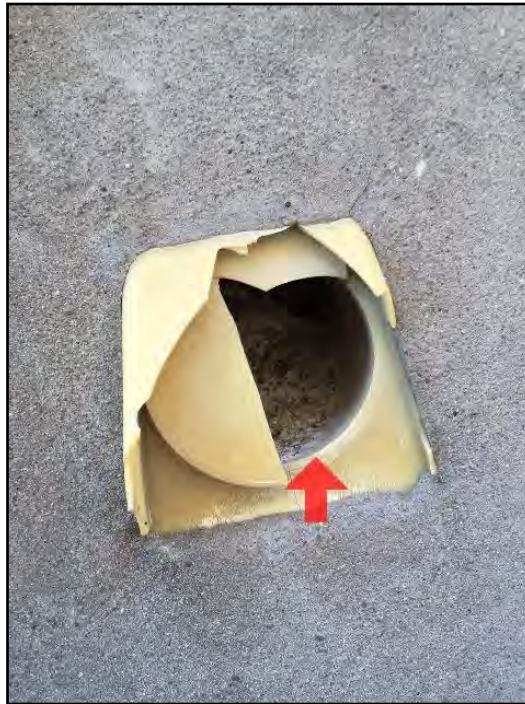
2. • Damaged or Dirty Vent Cap

Implication(s): Air, moisture or pest entry

1. Damaged or Dirty Vent Cap

Task: Replace

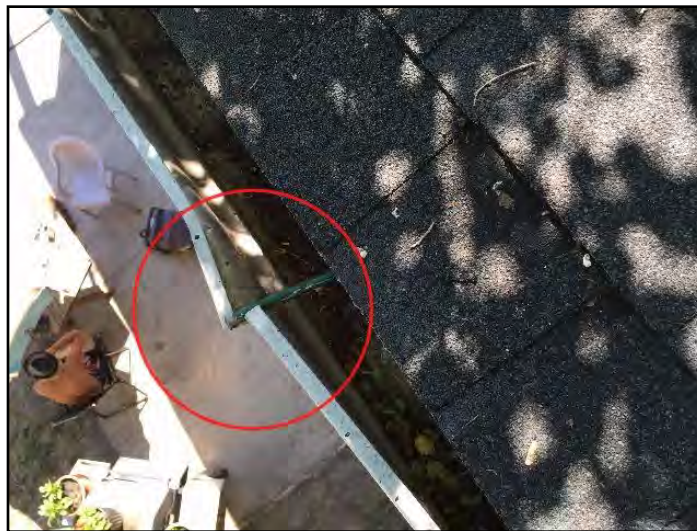
4. Condition: • [Loose or damaged](#)

Implication(s): Chance of water damage to contents, finishes and/or structure

2. Loose or damaged

Task: Repair or replace

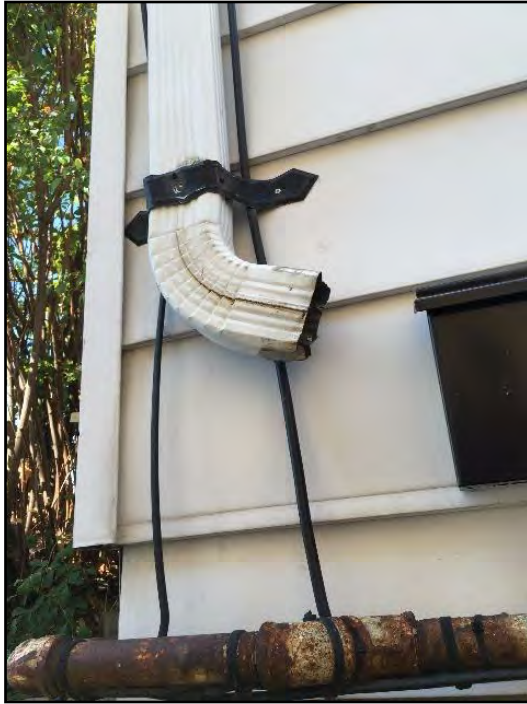
6. Condition: • [Downspouts end too close to building](#)

Implication(s): Chance of water damage to contents, finishes and/or structure

3. Downspouts end too close to building

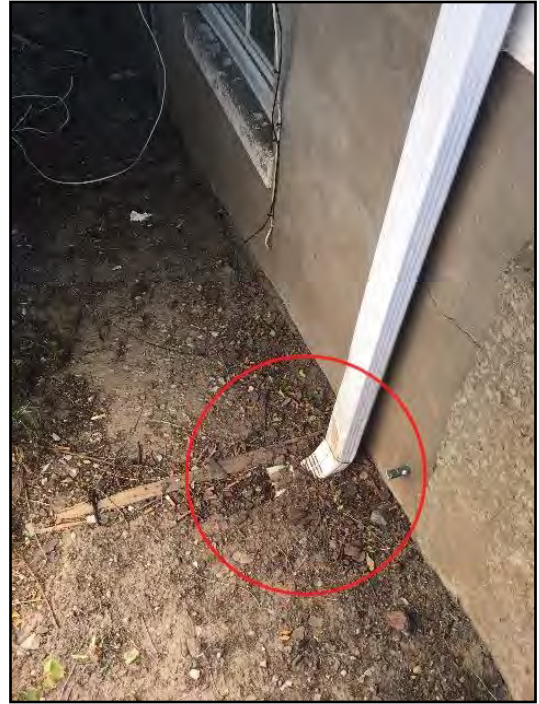
4. Downspouts end too close to building

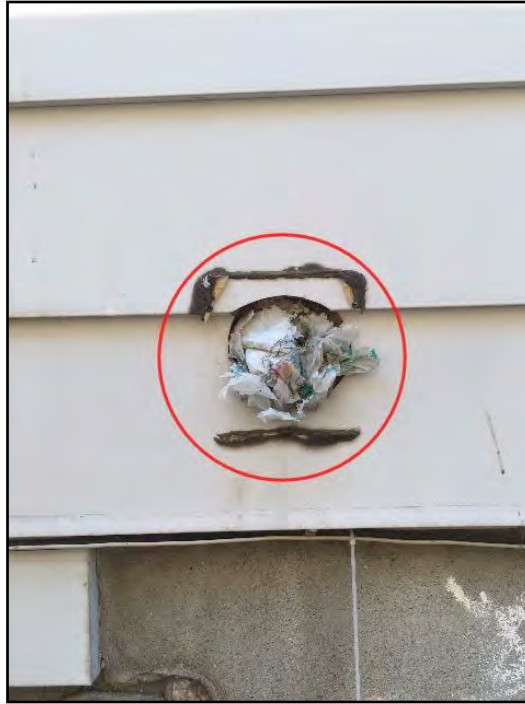
5.

7. Condition: • Circular hole in siding and plugged with a plastic bag. Two copper pipes were observed in this hole and are vulnerable to freezing in the winter. Insulate and repair this area. A vent was once terminated to the exterior here once.

Implication(s): Frozen pipes, flooding, water damage, pest entry, energy loss.

Task: Repair

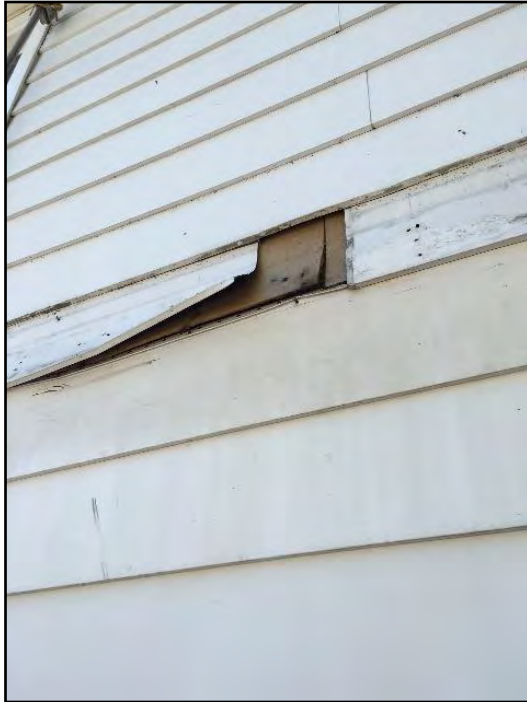
8. Condition: • [Loose or missing pieces](#)

Implication(s): Cosmetic defects | Chance of water damage to contents, finishes and/or structure

6. Loose or missing pieces

Task: Repair or replace

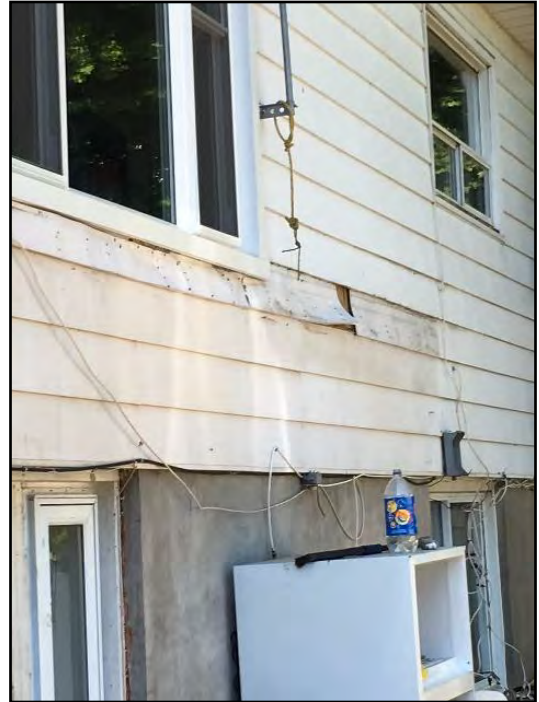
7. Loose or missing pieces

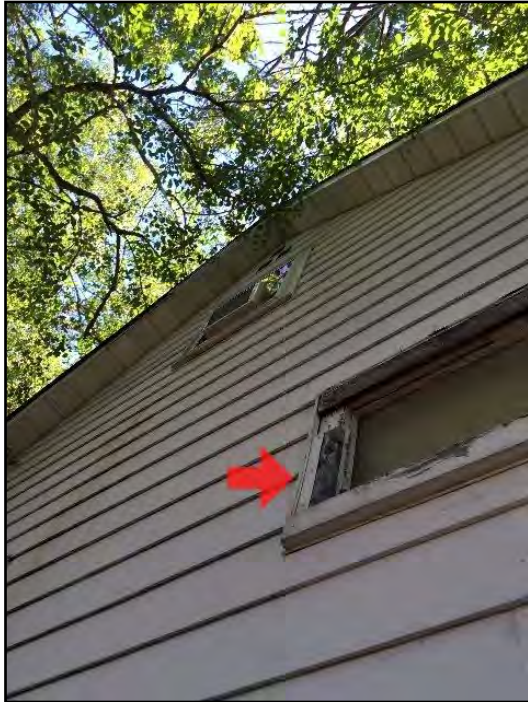
10. Condition: • [Paint or stain needed](#)

Implication(s): Material deterioration

8. *Paint or stain needed*

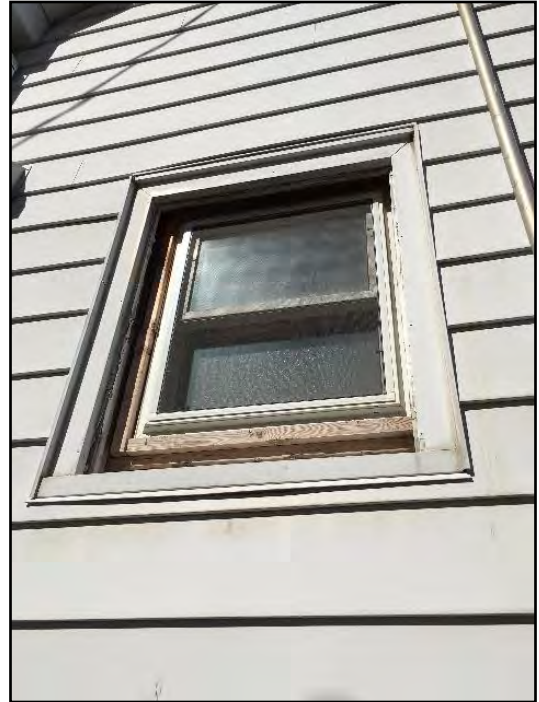
9. *Paint or stain needed*

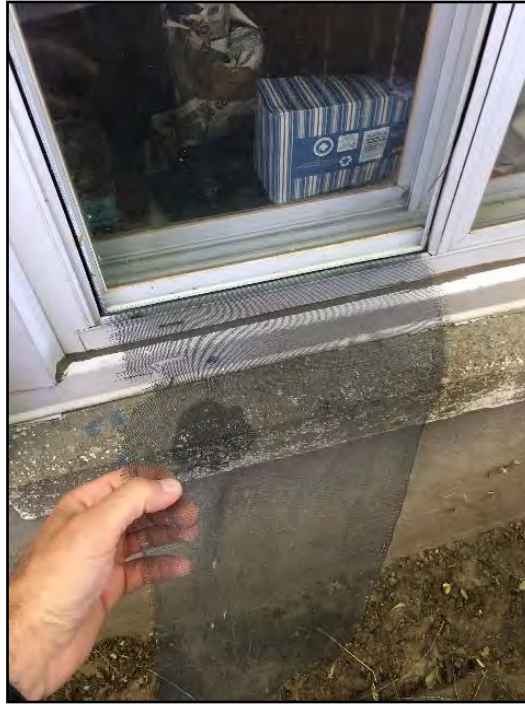
11. **Condition:** • [Torn or holes](#)

10. Torn or holes

Task: Repair or replace

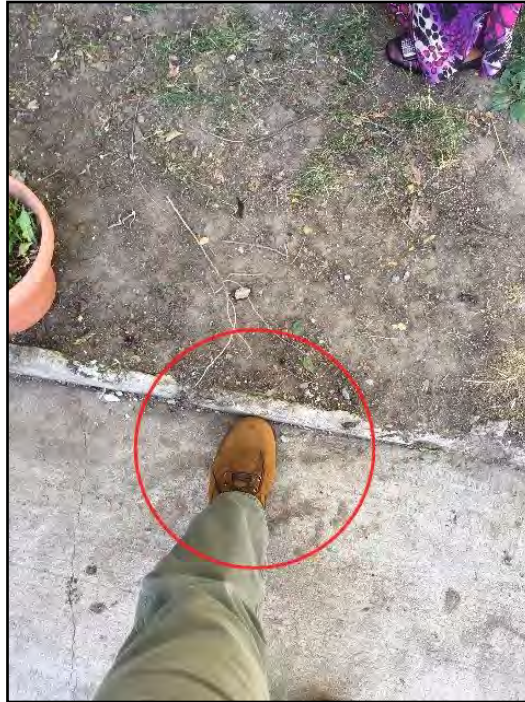
13. Condition: • [Trip hazards](#)

11. Trip hazards

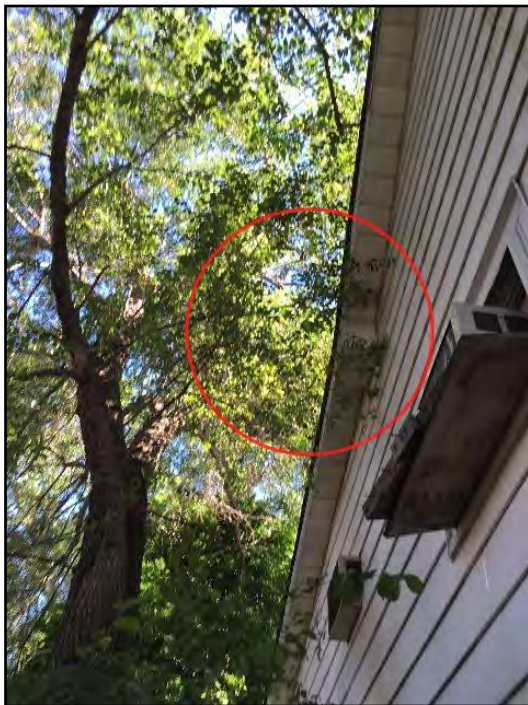
14. Condition: • [Trees or shrubs too close to building](#)

Implication(s): Chance of water damage to contents, finishes and/or structure | Chance of pests entering building | Material deterioration

12. Trees or shrubs too close to building

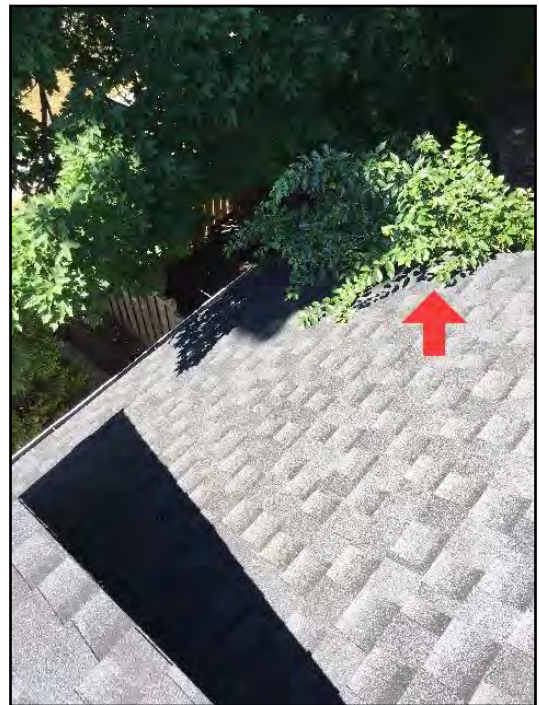
13. Trees or shrubs too close to building

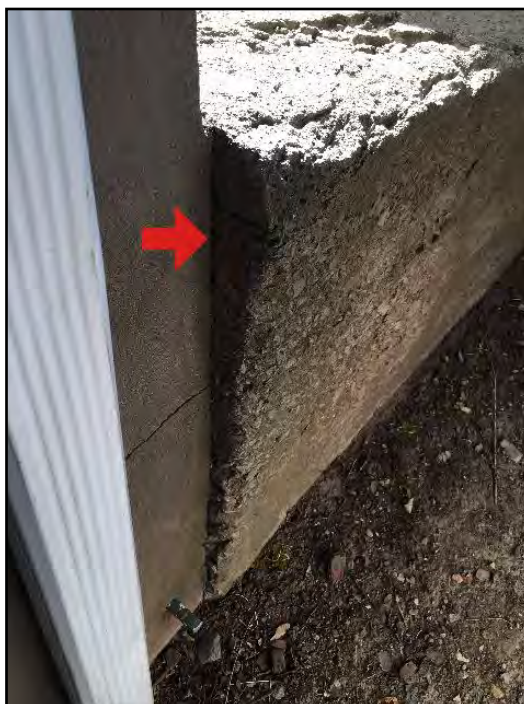
15. Condition: • [Leaning](#)

14. Leaning

This wall will need to be replaced in the future. Monitor and replace when necessary.

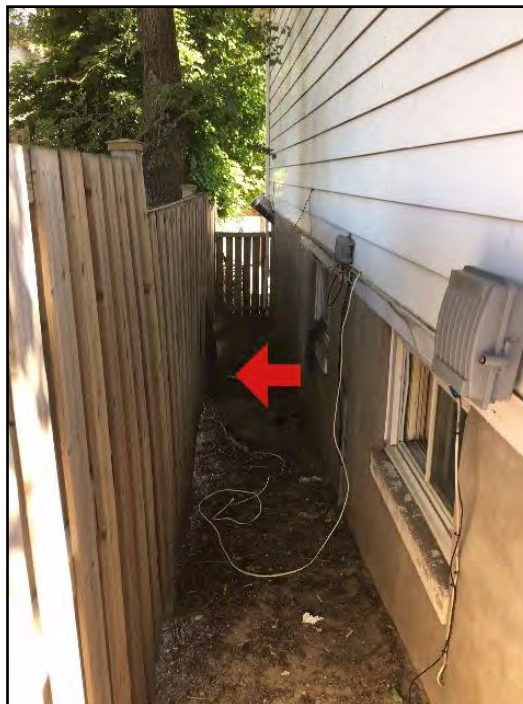
16. Condition: • [Large trees close to building](#)

15. Trees or shrubs too close to building

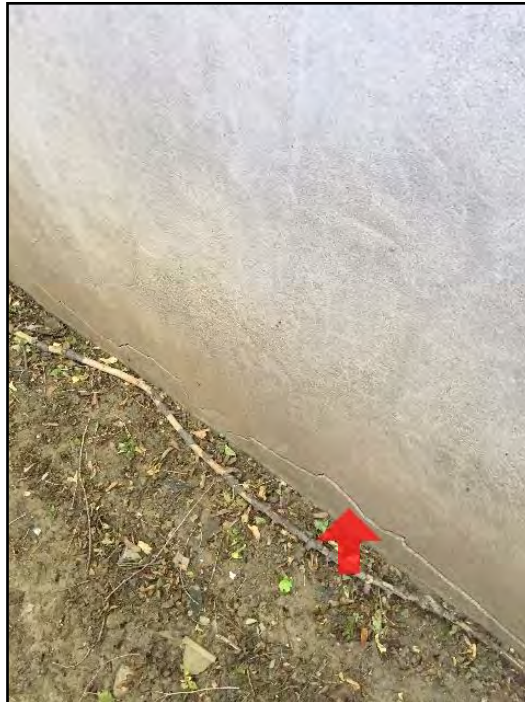
17. Condition: • [Parging damaged or missing](#)

Hairline cracks are normal in parged surfaces; parging that is separating from the concrete block base should be repaired. Parging is a cosmetic and sacrificial material applied to concrete surfaces.

Implication(s): Chance of damage to structure | Shortened life expectancy of material

16. Parging damaged or missing

Task: Repair

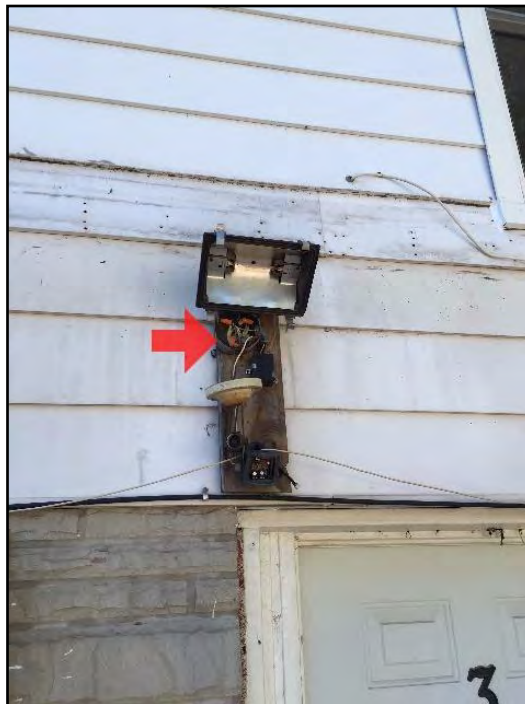
21. Condition: • [Open splices](#)

Implication(s): Electric shock | Fire hazard

17. Open splices

Task: Correct

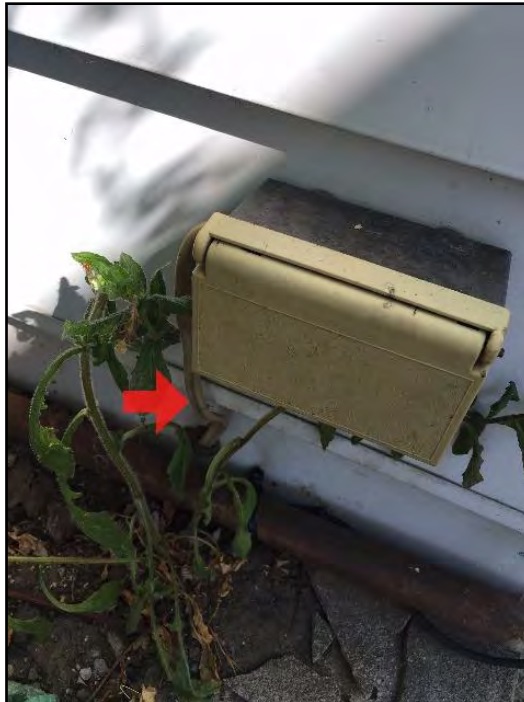
24. Condition: • [Inoperative](#)

This receptacle was not working and the wire is not protected from mechanical damage and the weather. Have your electrician correct this.

18. Inoperative

Task: Repair or replace Protect

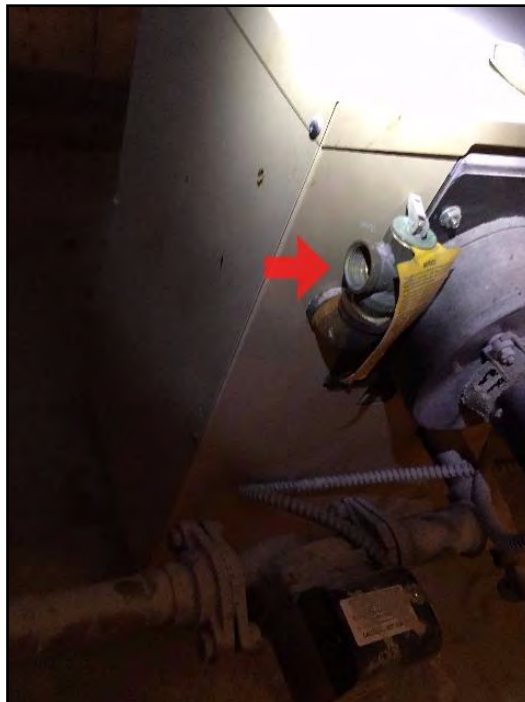
32. Condition: • [No pipe extension](#)

Scalding and damage to near by people and drywall is possible if this valve opens due to high pressures. A discharge tube should be installed 6"-12" from the floor.

19. No pipe extension

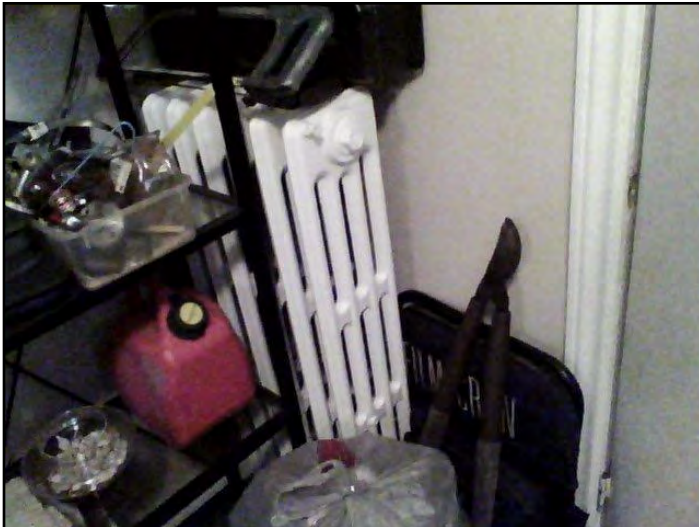
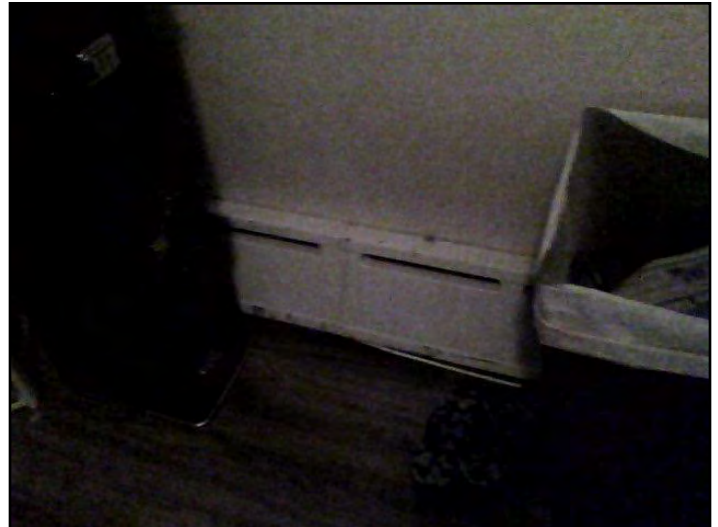
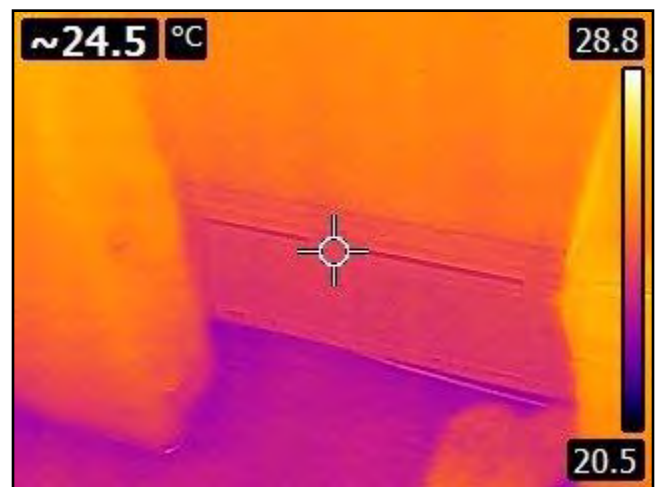
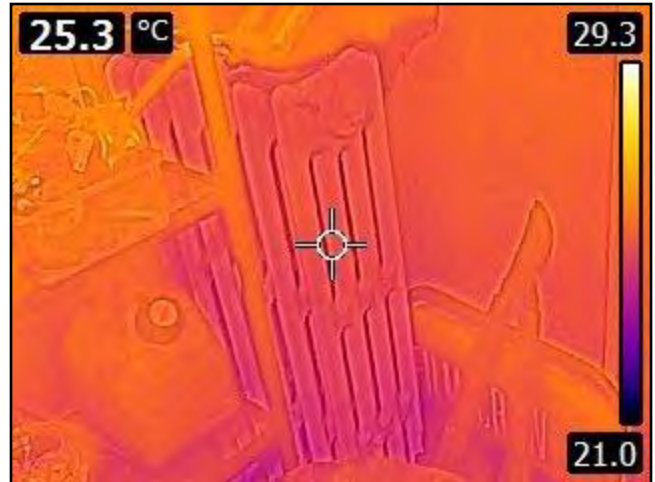
33. Condition: • [Cold](#)

Some Rads were not responding to heat in unit 3. Further evaluation by a boiler technician is recommended.

20. Cold Unit 3 bedroom Pic B

21. Cold Unit 3 bedroom Pic A

23. Cold Unit 3 bedroom Pic A

25. Cold Unit 3 bedroom Pic B

Task: Further evaluation

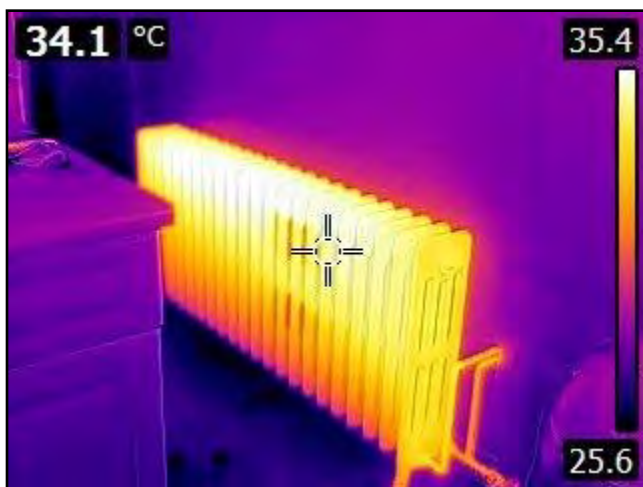
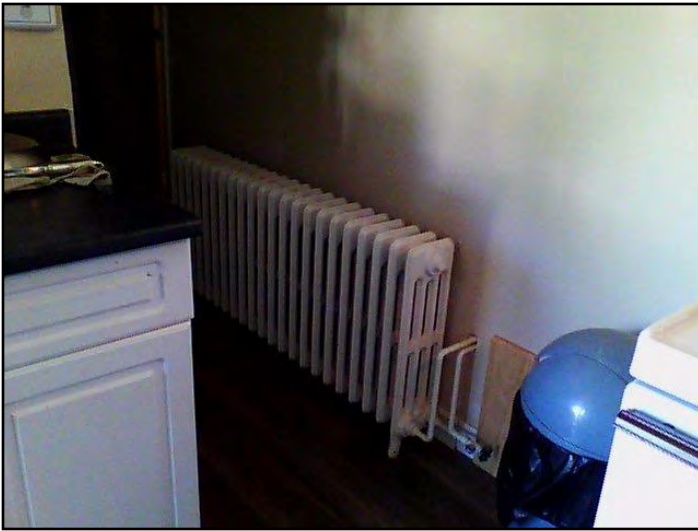
22. Hot Rad in Unit 3 Kitchen Pic C

24. Hot Rad in Unit 3 Kitchen Pic C

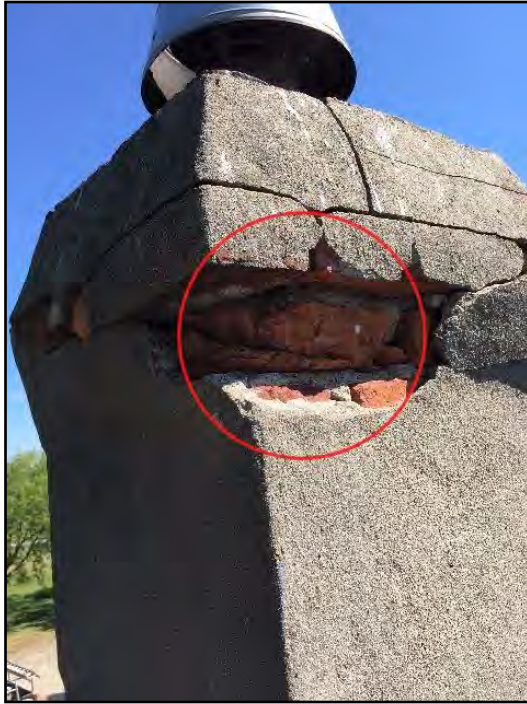
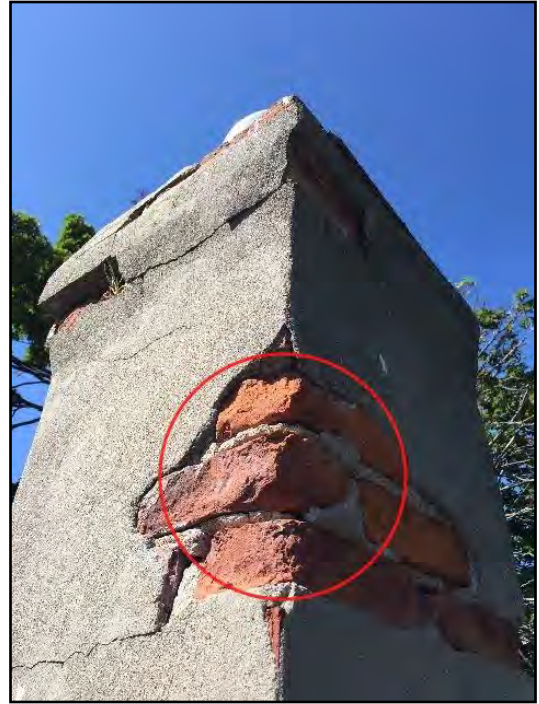
34. Condition: • [Loose, missing or deteriorated masonry](#)

Implication(s): Material deterioration

26. Loose, missing or deteriorated masonry

27. Loose, missing or deteriorated masonry

Task: Repair

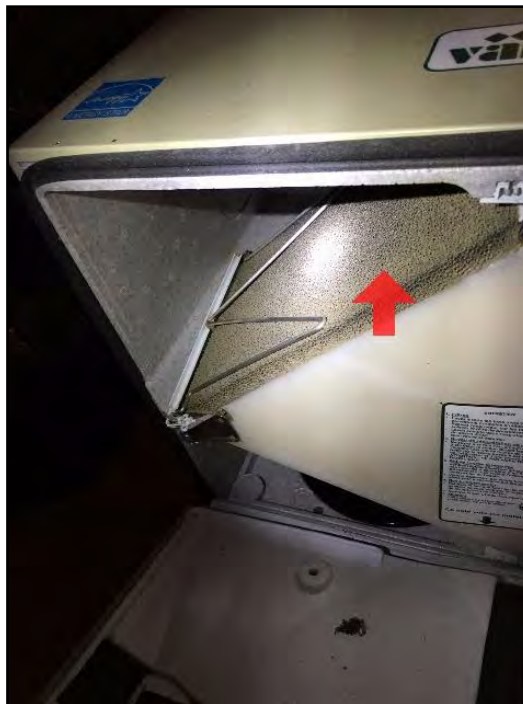
35. Condition: • [Dirty](#)

28. Dirty

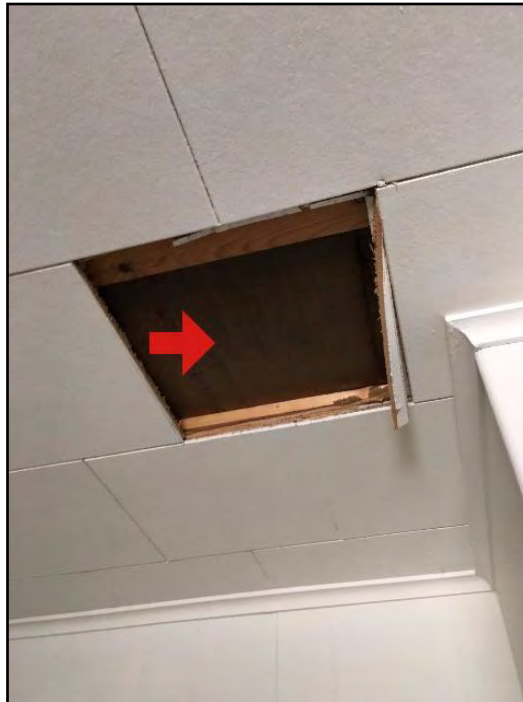
A ceiling tile was missing and I was able to see the type of insulation and vapour barrier used. Keep in mind that this doesn't confirm the whole roof is like this but highly probable.

29. Kraft paper

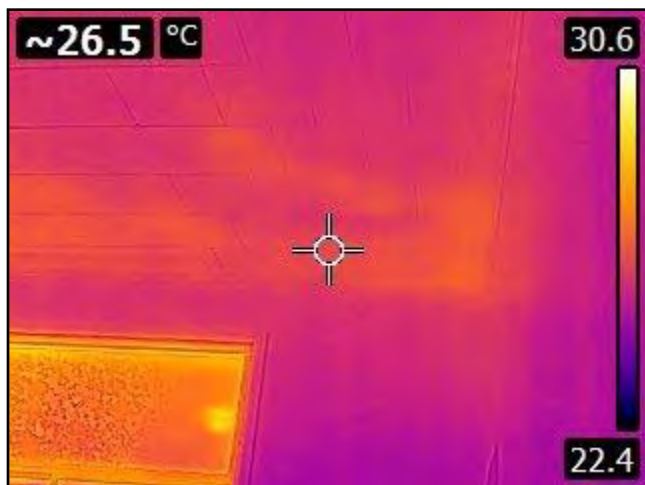
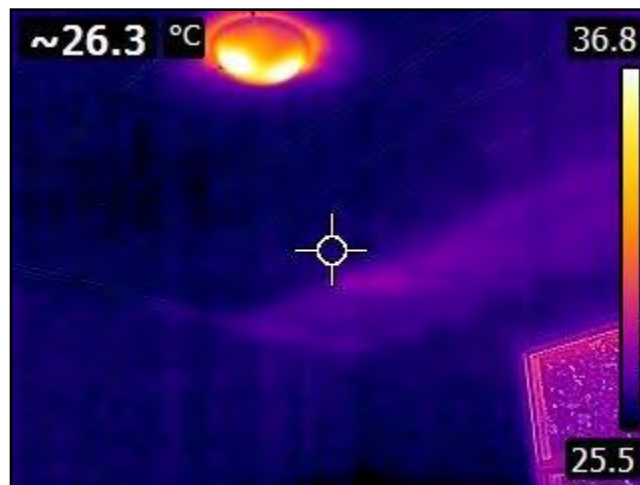
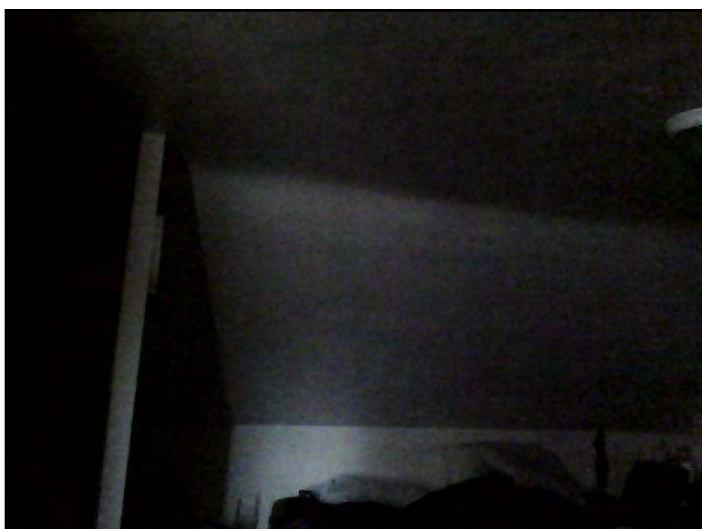
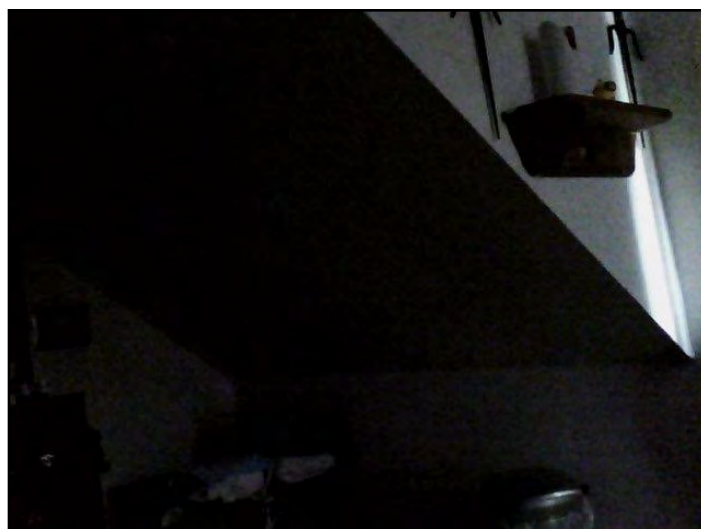
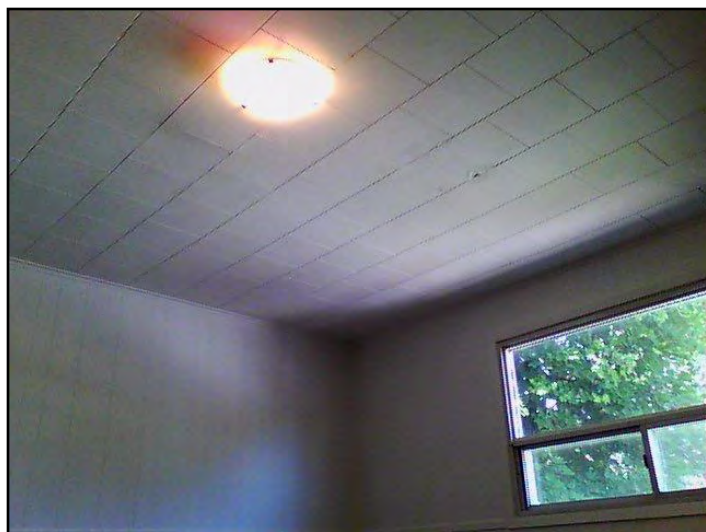
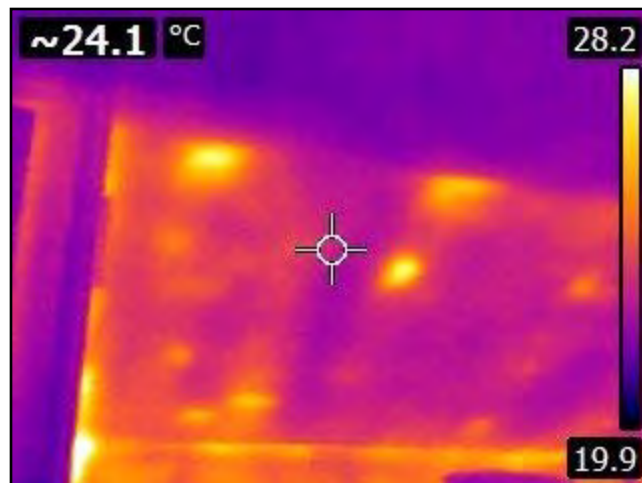
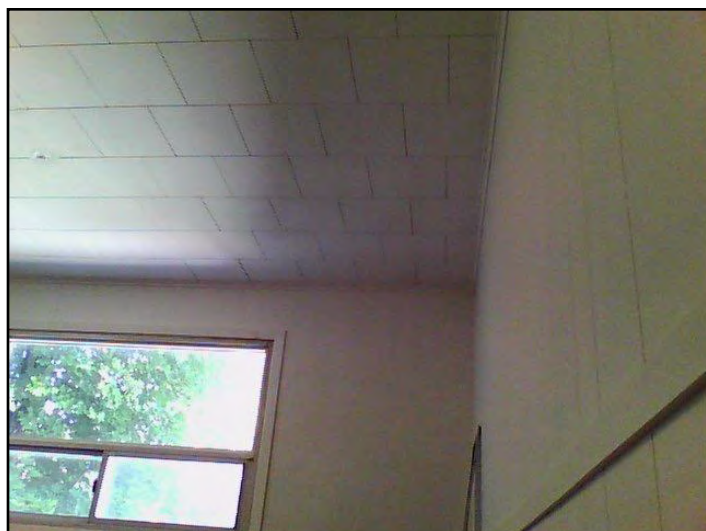
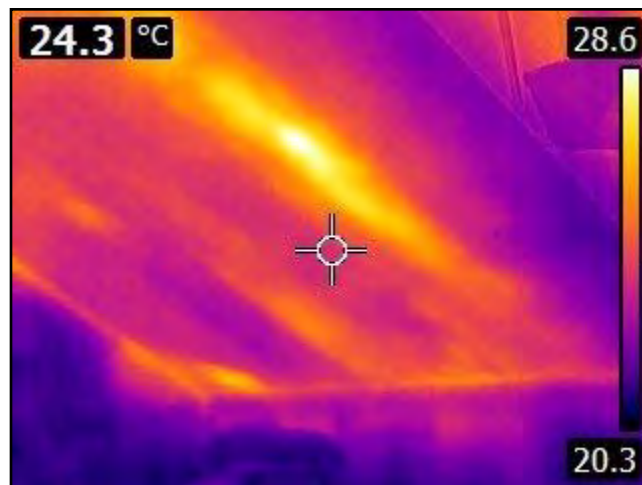
36. Condition: • Although there was no Access to any type of roof and wall space, one can assume that this home is below modern standards as far as energy savings go. It is important to be aware that only by invasive means can one truly and accurately determine the amount of insulation behind finished areas.

Implication(s): Reduced energy savings and increased losses over time.

30. Possible insulation voids Pic A

31. Possible insulation Voids Pic B

32. Insulation Voids Pic C

33. Insulation Voids Pic D

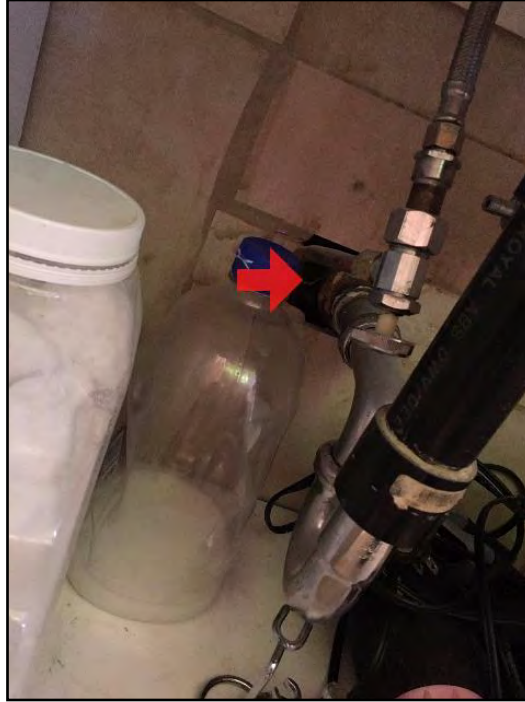
38. Condition: • Slow draining!

Note this trap arm connects to galvanized steel drain pipe. There is a possibility that it is corroded and affecting drain performance. If after cleaning out the trap no performance improvement is noted, have a plumber further evaluate.

38. *Slow draining!*

Task: Clean

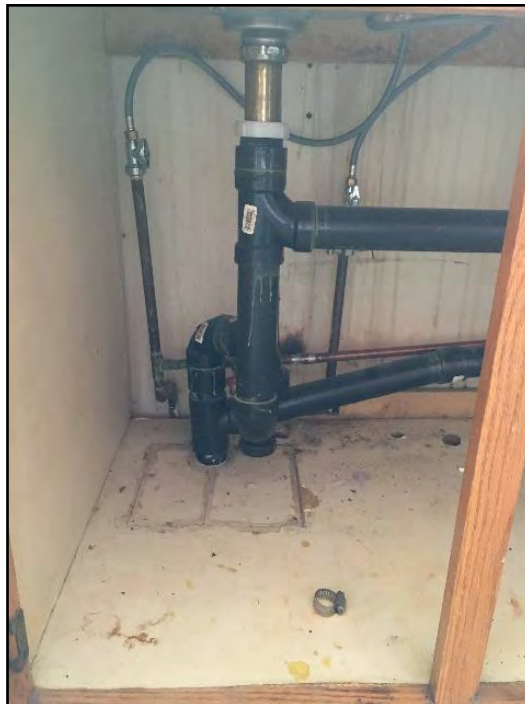
39. Condition: • [Nonstandard shape or material](#)

This arrangement seemed to still perform its function. Monitor and have it replaced and improved in next remodel if necessary. Traps shaped in an S can often self siphon and allow sewer gases into the home.

39. Nonstandard shape or material

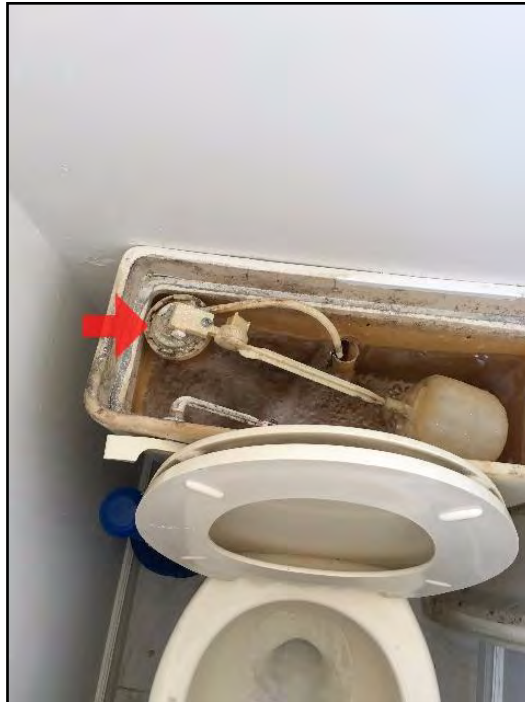
40. Condition: • Replace valve in toilet as it is not performing as intended.

Implication(s): Leakage and poor performance

40. Replace valve in toilet as it is not...

Task: Replace

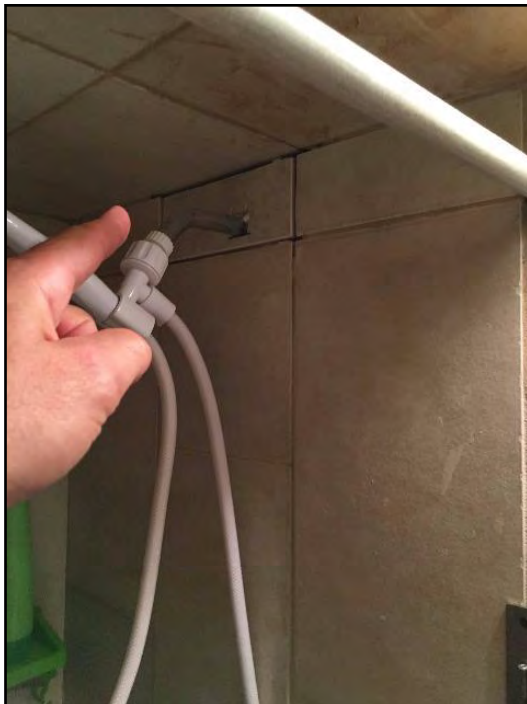
41. Grout missing

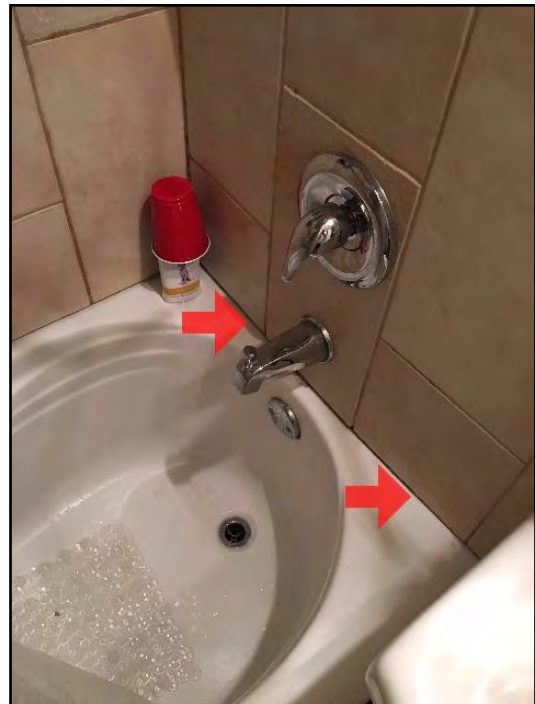
41. Condition: • [Caulking loose, missing or deteriorated](#)

Implication(s): Chance of water damage to contents, finishes and/or structure

42. Caulking loose, missing or deteriorated

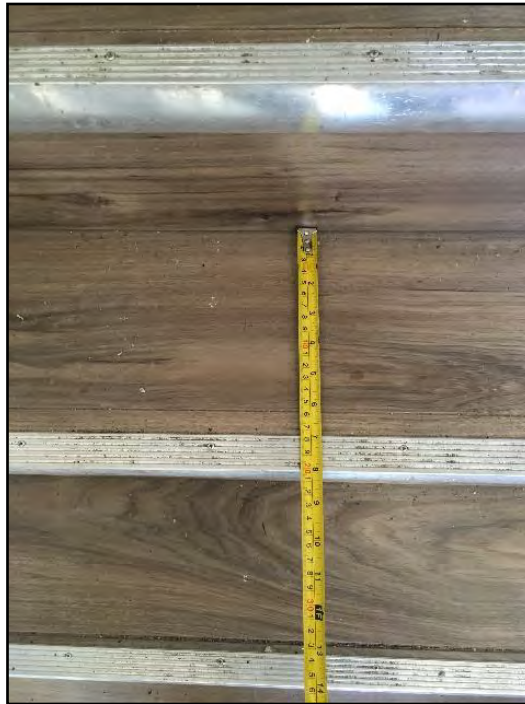
Note: Although this isn't a code inspection, Unit 2 stairs are just a hair under code minimum. People with large shoe sizes should take care.

43. Inspected

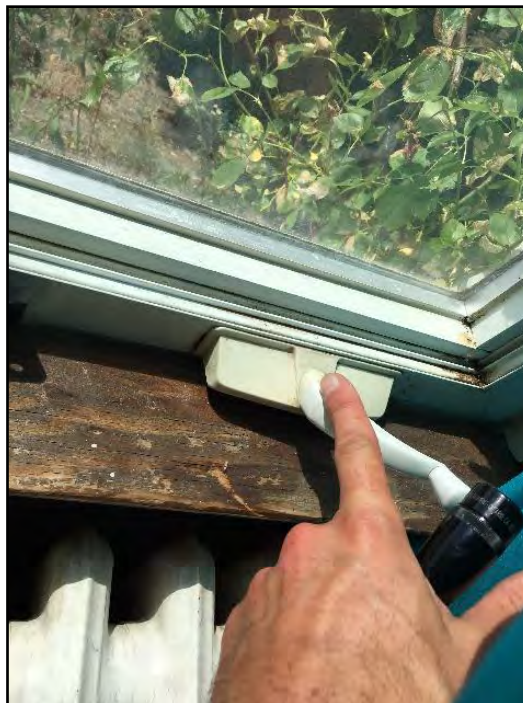
42. Condition: • [Inoperable](#)

44. Inoperable

Task: Repair or replace

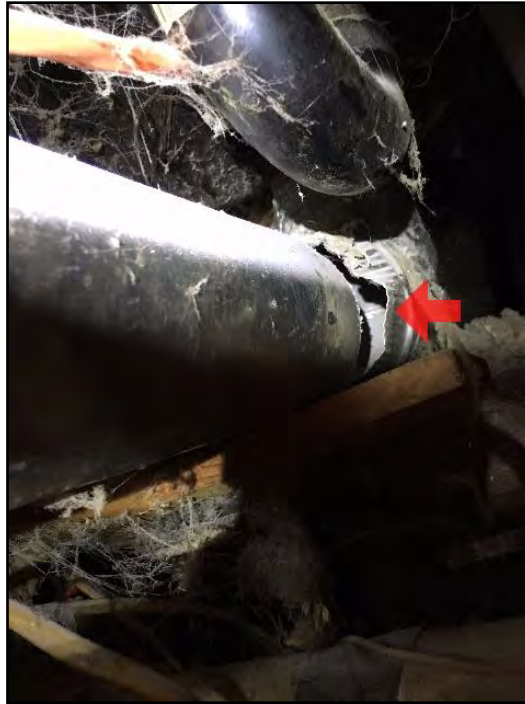
45. Leak

Task: Repair
