Your Inspection Report

427 Queenston Street
St.Catharines, ON L2P2Y3

RE: Report No. 1239, v.2
427 Queenston Street
St.Catharines, ON
L2P2Y3

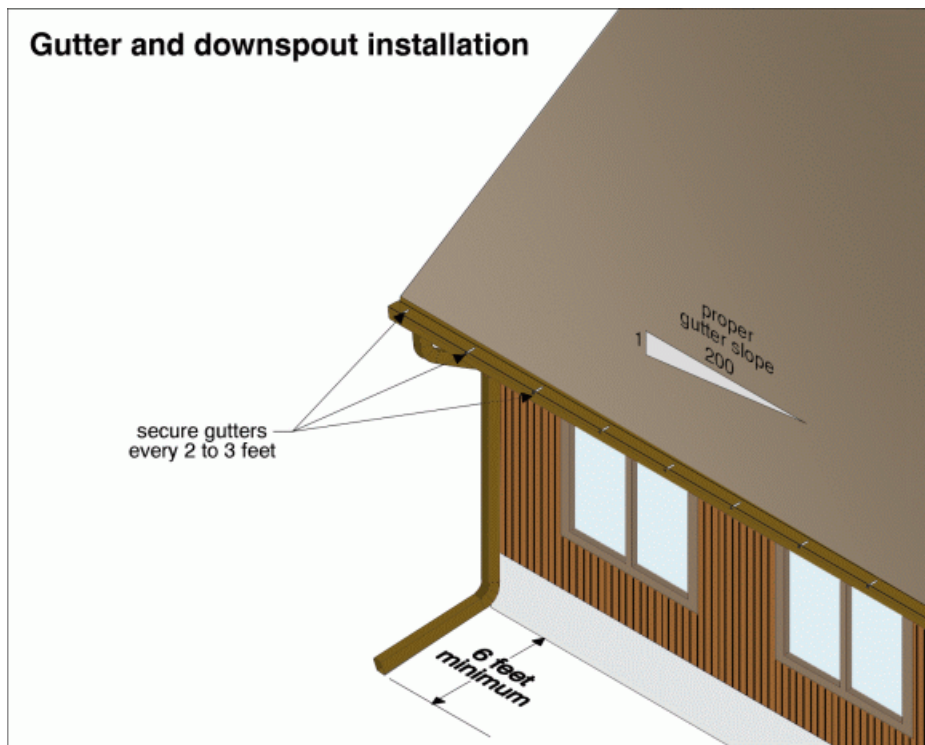
Downspout extension too short

6. Condition: • [Downspouts end too close to building](#)

Implication(s): Chance of water damage to contents, finishes and/or structure

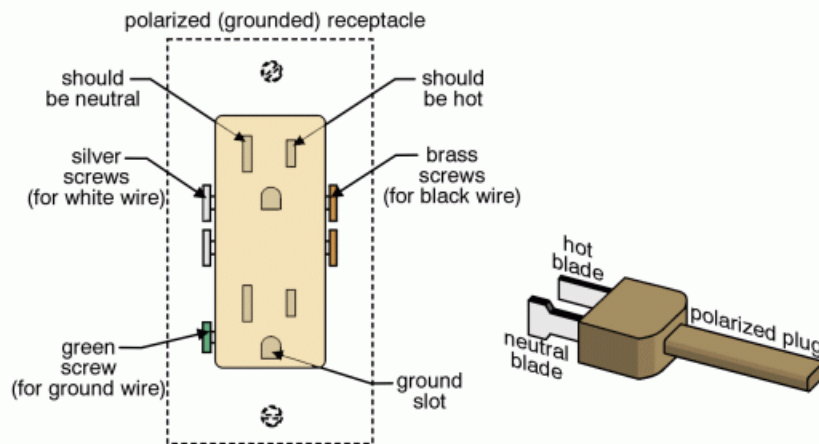
Reversed polarity

Condition: • [Reversed polarity](#)

when the polarity is reversed, the wide receptacle slot is (incorrectly) hot and the narrow slot is neutral - this is not uncommon when people forget that the black wire should be attached to the receptacle's brass screws

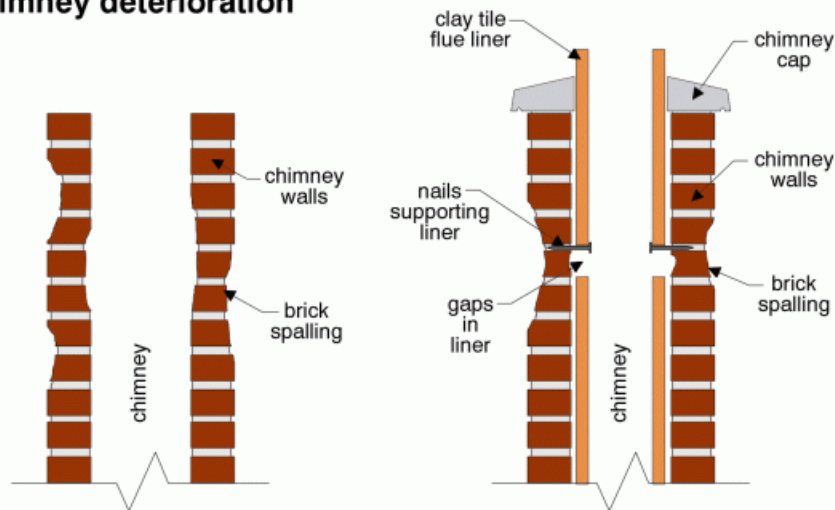
Chimney deterioration

unlined chimneys are particularly prone to damage caused by condensation of flue gases - the damage tends to be worse near the top of the chimney

even lined chimneys can suffer from condensation related brick damage
